ROYAL AIRCRAFT ESTABLISHMENT

Technical Report 83018

February 1983

**INVESTIGATION OF PULSED
PERFORMANCE OF AN ELECTROTHERMAL
HYDRAZINE THRUSTER, USING A SPECIAL
SEE-THROUGH THRUSTER**

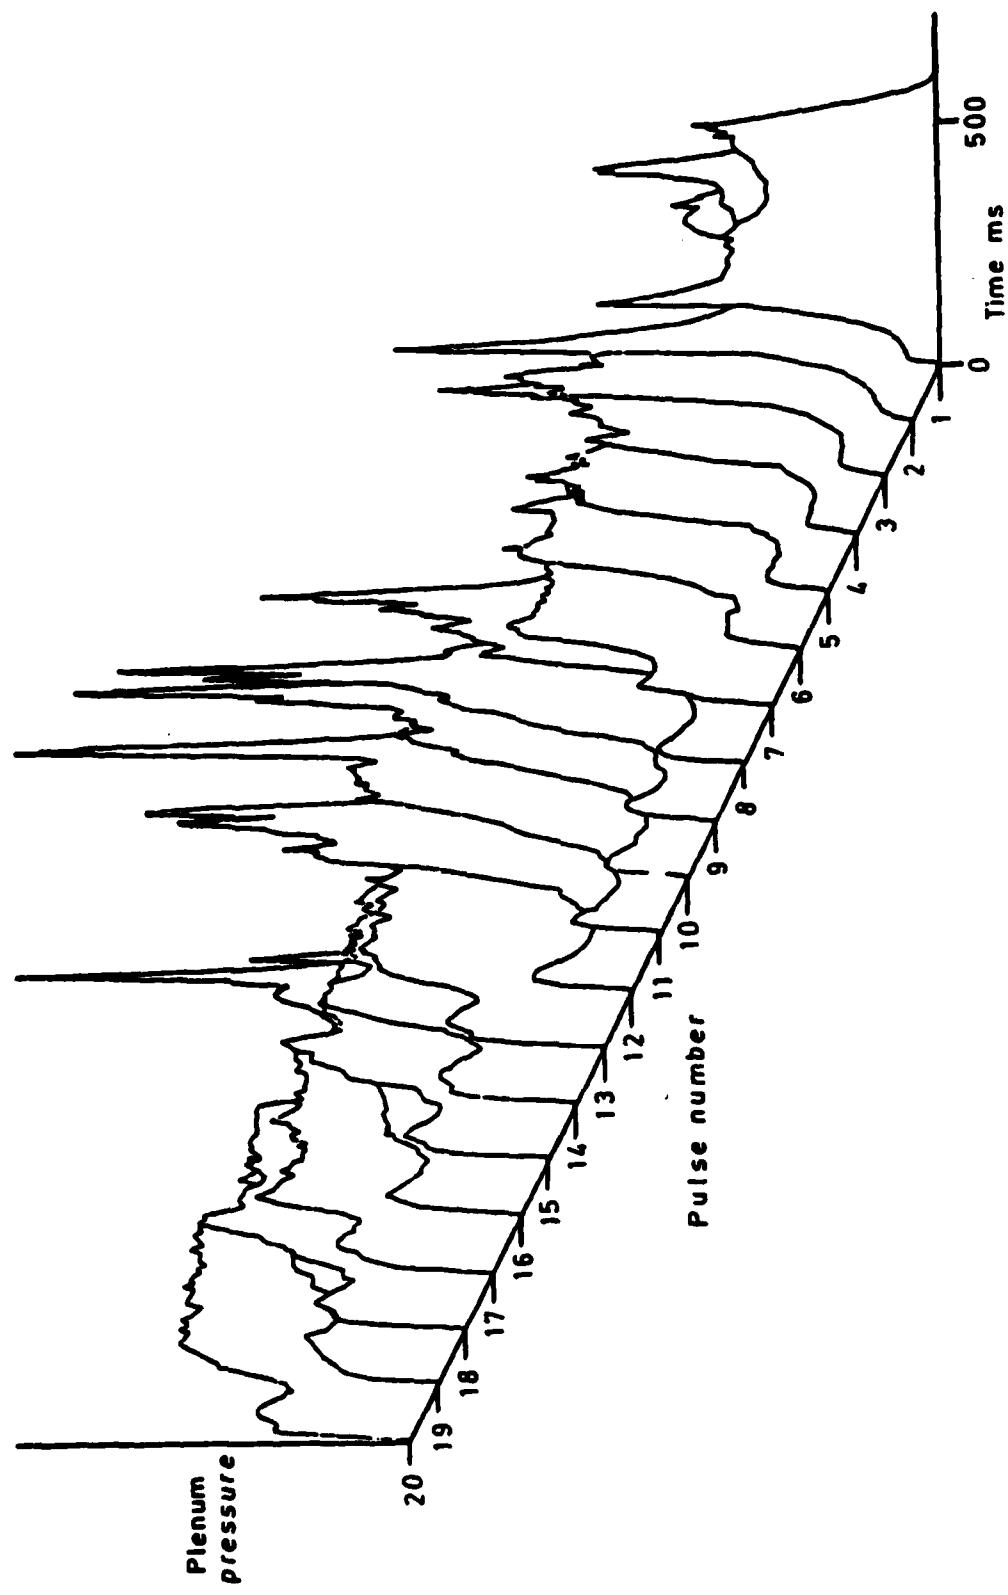
Hydrazine thrusters are used in many spacecraft propulsion systems to provide small impulses for attitude control. During the development of an electrothermal hydrazine thruster (EHT) some problems were experienced with its pulsed performance¹. On investigation, comparable performance anomalies were recorded during pulsed operation of a similar 0.2N RAE prototype EHT (Fig 1). A projection of the plenum pressure profiles from twenty consecutive thrust pulses is shown in Fig 2, recorded during an experimental test of the prototype EHT. The performance was typified by poor transient response and the occurrence of apparently random plenum pressure spikes, especially during the first few seconds of operation.

Fig 2 Train of typical prototype thruster pulses

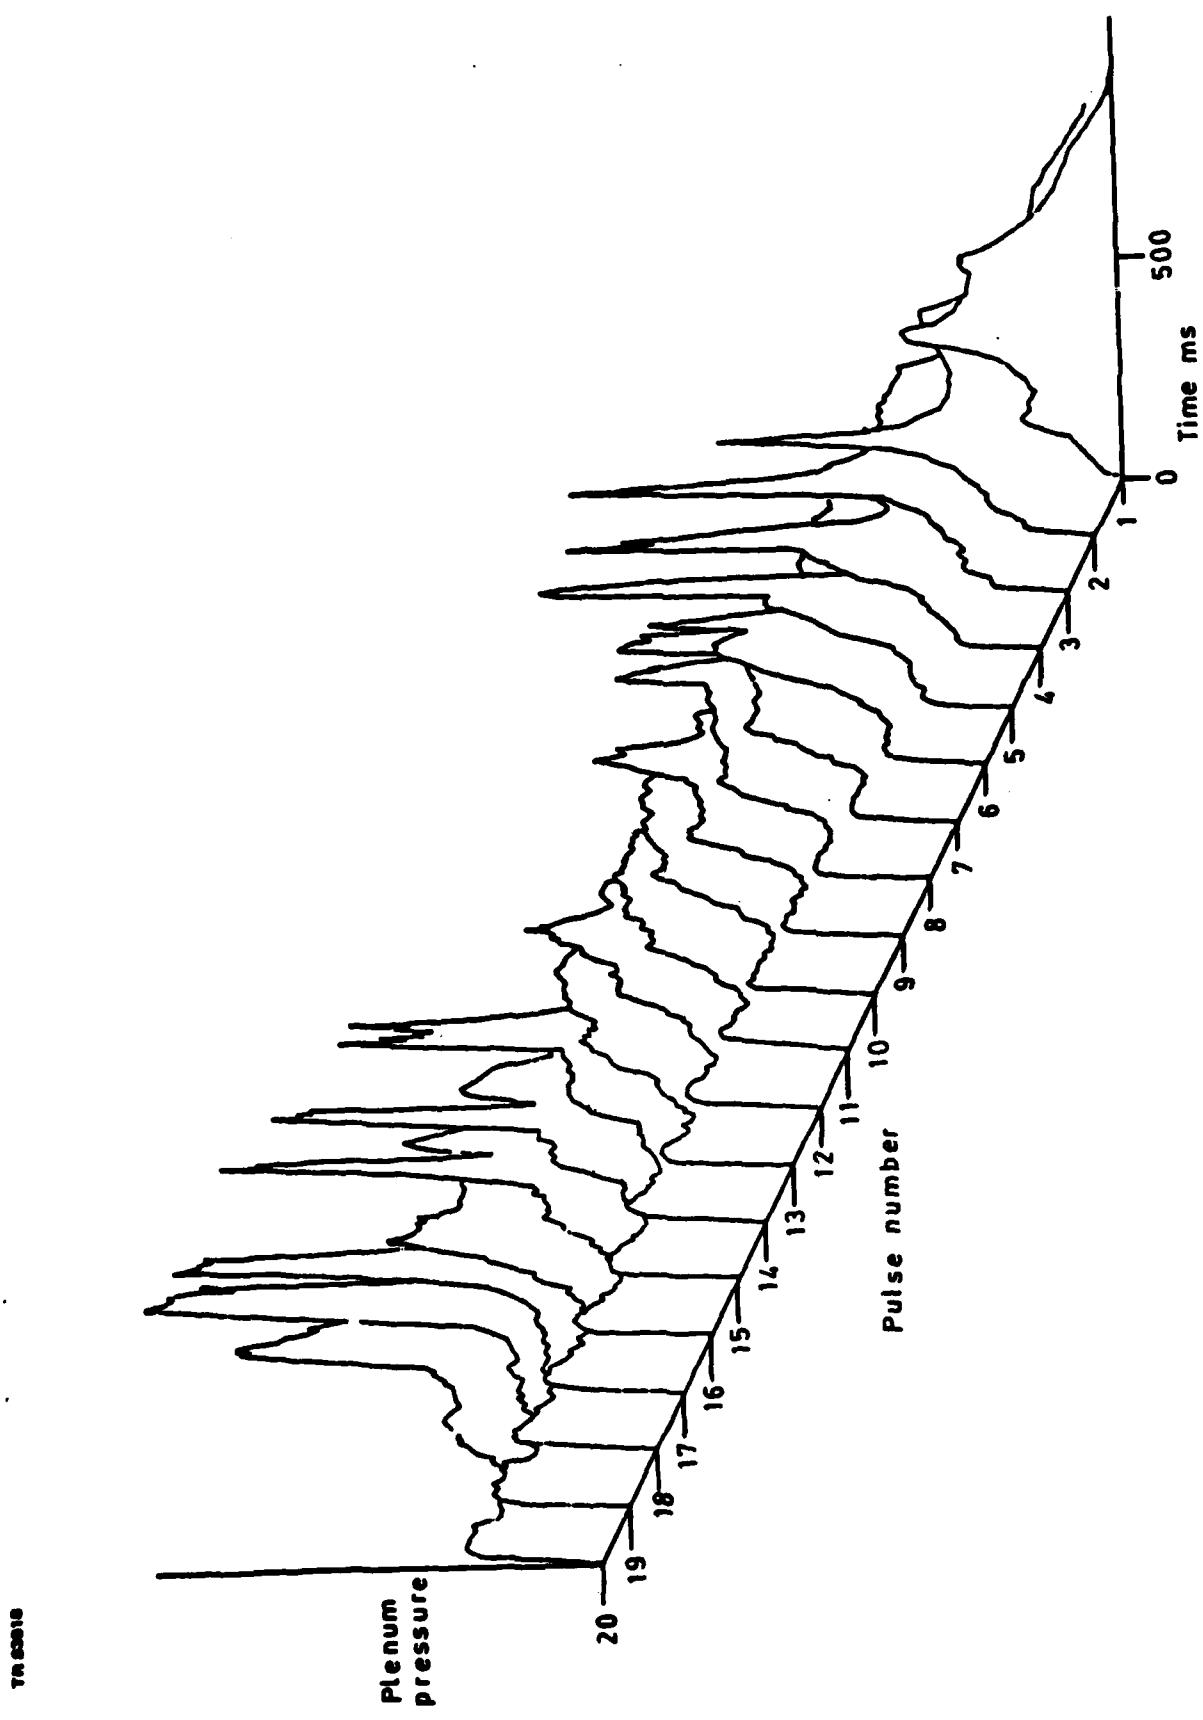
A preliminary test was carried out to validate the use of the see-through thruster. Details are recorded in Table 1. The results were encouraging and showed typical plenum pressure profiles (Fig 11) similar to those of the prototype EHT (Fig 2). This was considered adequately representative of the prototype device. Comparison of the analogue recordings with the cine film record further supported the use of the thruster as a means of investigating prototype thruster performance.

Fig 11 Train of typical see-through thruster pulses

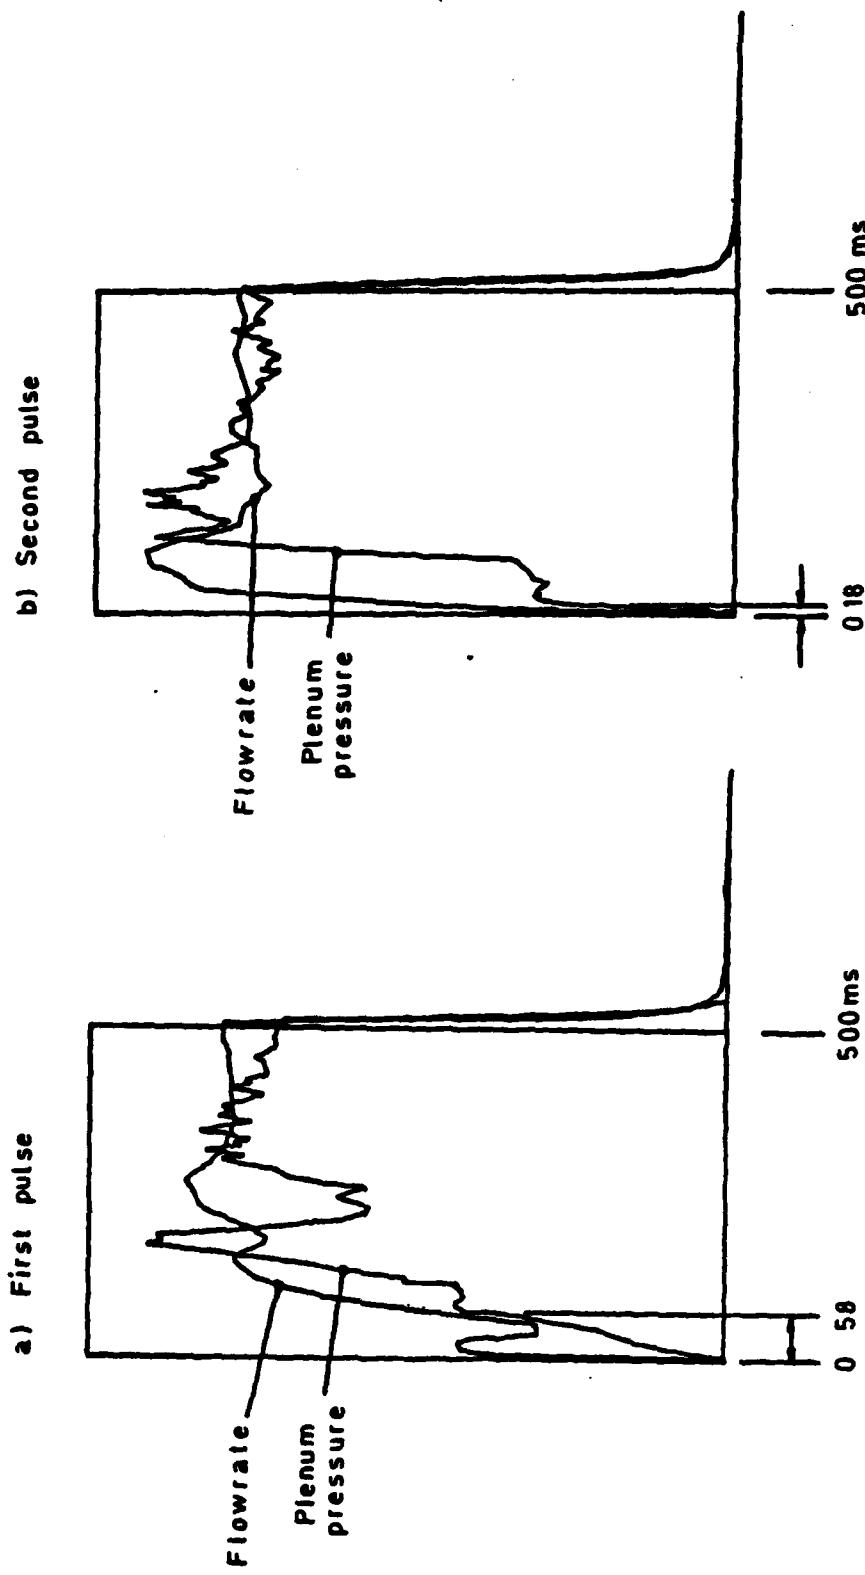
The effect which was most evident at the start of first pulses is illustrated in Fig 12. A spray consisting of a mixture of vaporized and atomised propellant can be seen emerging into the head space of the thruster. The effect usually decreased in duration with subsequent pulses in a train. Examples for first and second pulses are given for comparison in Fig 13a&b. The flow of propellant through the injector was inhibited during this phase, with a resultant low plenum pressure, even though the initial rate of pressure rise was high.

When the end of the injector tube in contact with the thruster was well above the boiling point of the liquid, propellant flow extracted heat from the tube wall causing complete or partial vaporization of the propellant. When vaporization was incomplete, turbulence caused atomisation of the remaining liquid in the flow stream and the increased surface area resulted in initially high vaporization and decomposition rates. The inhibition of propellant mass flow resulted from the change of phase within the confines of the injector tube. The duration of this 'thermal choking' increased when the supply pressure was reduced.

Fig 13e&b First and second pulse characteristics

With the particular design of the injector/thruster body interface thermal choking was inevitable, especially for first pulses, as the injector temperature would then be close to that of the body. To minimise this effect the injector/body interface would need to be redesigned to reduce the temperature of the injector tube.

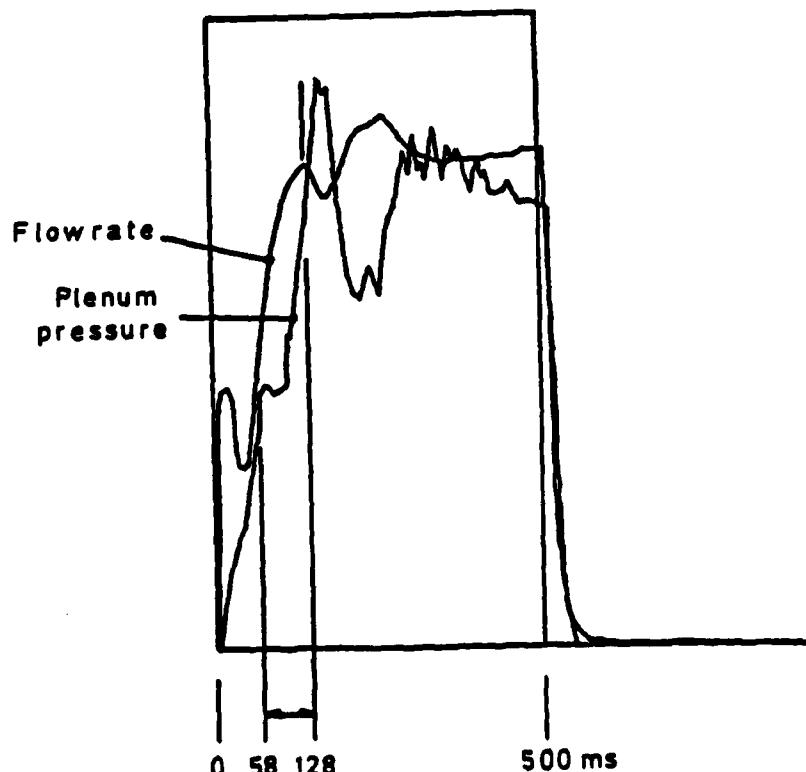
This flow condition, illustrated in Fig 14a, followed the initial vaporization/atomisation phase described above. Fig 14b shows that over the duration of the effect the propellant flow rate increased to the stage where full injector flow was achieved. Vaporization inside the tube ceased, marking the end of thermal choking.

Since the propellant entered the chamber as a liquid stream of relatively low surface area compared with the previous spray phase, vaporization and consequently decomposition of the propellant was not as rapid. During this phase of increasing propellant flow, the pressure in the thrust chamber levelled off or even decayed slightly from the initial peak produced by the sprayed flow, Fig 14b. The chamber pressure did not rise until the vaporization rate of propellant exceeded the rate prevailing during the initial vaporization phase.

Fig 14a&b Turbulent propellant inlet flow

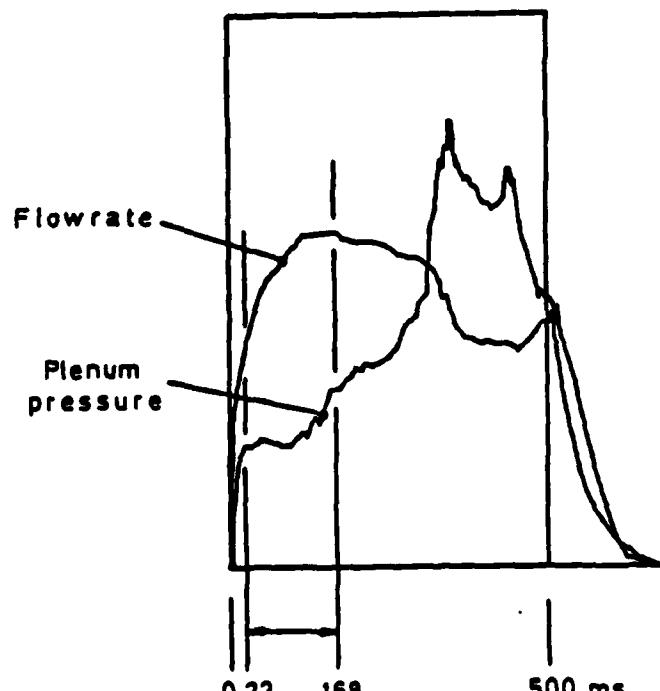
When the incoming liquid stream first became incident on the gauze matrix the liquid was rejected from a small quenched zone at the surface of the gauze, as seen in Fig 15a. The elevated temperature of the gauze caused partial vaporization at the zone of impact and consequent breaking up of the stream. This continued until the liquid stream reduced the temperature at the zone of impact below some critical but indeterminate value. During this phase the vaporization rate of the propellant was low and generally less than the incoming flow rate. The plenum pressure was below the steady state level (Fig 15b), although the inlet flow rate was generally fully established. Also, the pressure record exhibited some small fluctuations due to the sporadic nature of vaporization and decomposition of the propellant droplets. The higher the thruster temperature at the start of a pulse, the longer the state could prevail, and as a train of pulses progressed the effect could become more pronounced.

Fig 15a&b Propellant droplets film-boiling in thruster

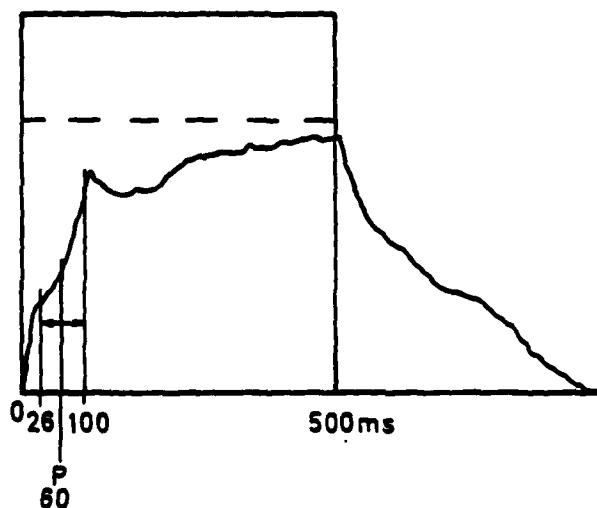
When rejection of the liquid stream ceased, the propellant remained in contact with the gauze surface and gradually accumulated at a quenched zone (Fig 16a), showing the vaporization rate was below the incoming flow rate. As cooling continued the accumulating liquid spread across the surface of the gauze. From Fig 16b it can be seen that during this phase the plenum pressure was below the steady level as a result of the reduced vaporization rate. The pressure rose towards the steady level as the vaporization rate increased due to the increase of surface area of the accumulating liquid.

Fig 16a&b Accumulation of propellant on the thruster gauze pack
(photographed at point 'P')

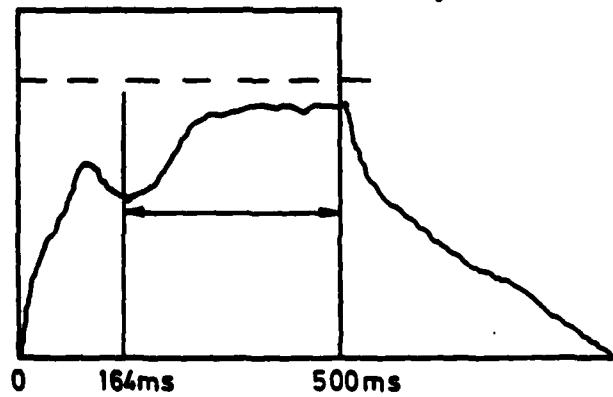
At lower mean gauze pack temperatures the accumulating propellant mass at the quenched zone locally cooled the matrix surrounding the zone and was totally absorbed into the gauze pack. Fig 17a shows the propellant stream being absorbed into the quenched zone. It is demonstrated by Fig 17b that the quenched zone expanded within the matrix until the vaporization rate, and hence the decomposition rate, equalled the incoming flow rate, when a steady plenum pressure was achieved.

When the inlet flow had been absorbed into the gauze matrix, as for example in Fig 17a, at the end of the pulse the liquid still present within the matrix slowly vaporized and decomposed to produce the relatively long pressure decay shown in Fig 17b.

Fig 17a&b First mode of steady state thruster operation

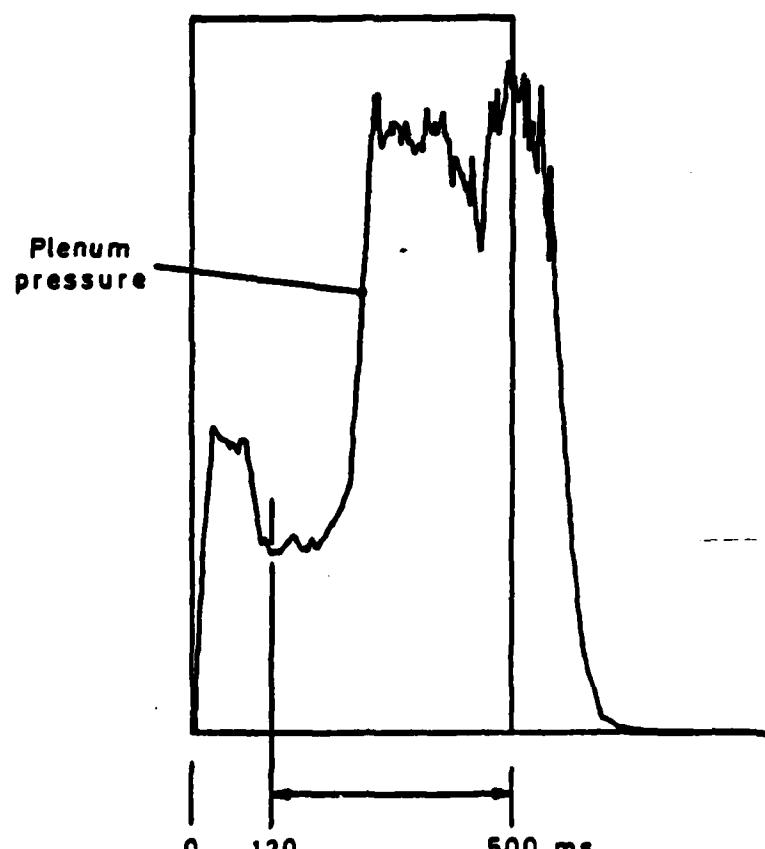
The mode of operation shown in Fig 18a occurred at higher mean gauze pack temperatures than the previous case. Expansion of the quenched zone within the matrix had ceased but accumulation of propellant mass continued into the head space until the vaporization and decomposition rates equalled the incoming mass flow rate. However, without the stabilising influence of the surrounding gauze matrix (which led to the smooth steady pressure shown in Fig 17b for the previous case) fluctuations in the vaporization rate led to the fairly rough pressure characteristic shown in Fig 18b, and led in some cases to pressure spikes. In the extreme the head space filled with liquid which decomposed very rapidly as its surface was forced into contact with the thruster walls. This resulted in a large pressure spike which caused the thruster body/quartz seal to vent the pressure in excess of the spring preload.

Fig 18a&b Propellant accumulation

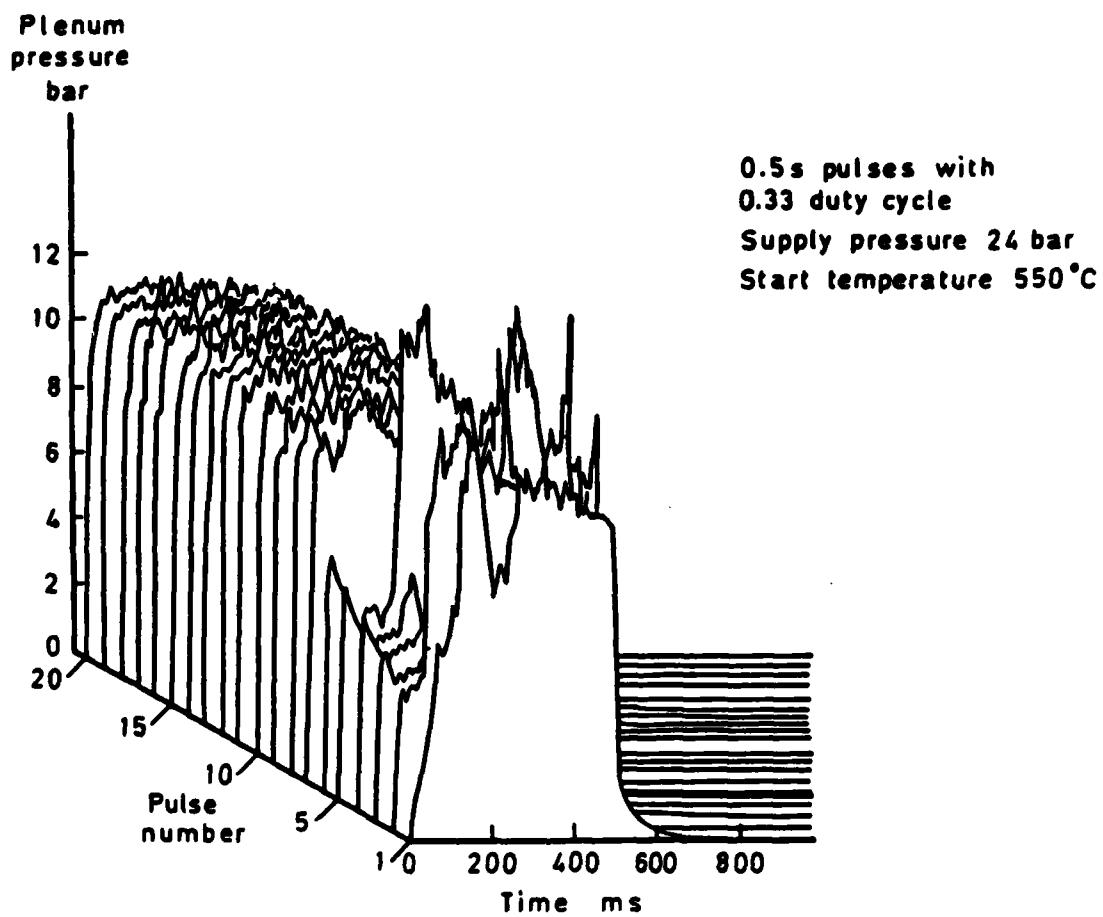
After several previous pulses in a train had raised the mean thruster temperature, a further mode of operation was observed (Fig 19, pulses 7 to 20). The liquid stream incident on the gauze matrix did not form a quenched zone and was rejected as a spray of small droplets into the head space of the thruster, as shown in Fig 20a. This figure bears a superficial resemblance to Fig 15a. However, comparison of the plenum pressure

Fig 19 Particular pulsed performance of see-through thruster

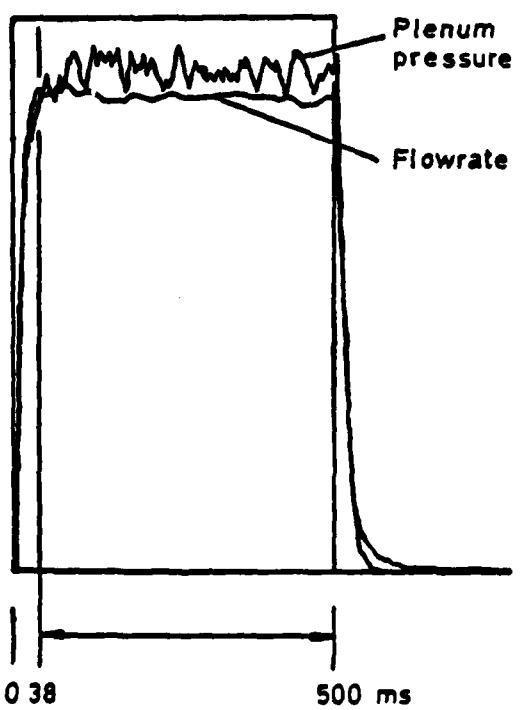
records for the two pulses (Figs 15b and 20b) shows that when this effect was present during the first of the pulses, the chamber pressure was low. As a result of the low vaporization rate, propellant was accumulating in the thruster. The increased vaporization and decomposition rate of the droplets in the second pulse resulted in very little accumulation of liquid, and consequently good response times for both rise and decay of chamber pressure.

Following the mode described in section 4.2.3 and illustrated by Fig 20, with little residual propellant and a high vaporization rate the pressure decay was extremely rapid.

Fig 20a&b Droplet spray mode

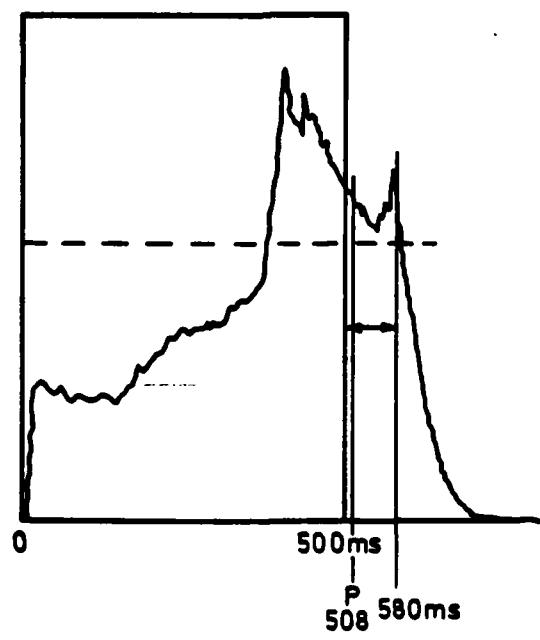
With an accumulation of liquid in the head space of the thruster on cessation of flow (Fig 21a), vaporization usually continued at a rate similar to that prevailing during the pulse. This resulted in the prolonged maintenance of plenum pressure after valve closure (Fig 21b), followed by a shorter decay than in the previous case. However, the vaporization rate of the accumulated propellant could increase when the cooling effect of the incoming stream ceased. This could result in a pressure spike prior to a more rapid decay of pressure, which was observed on some of the pulses shown in Figs 2, 11 and 19.

Fig 21a&bb Large volume of propellant in thruster after the end of a pulse
(photographed at point 'P')

The matrix design of the prototype thruster was inadequate to produce rapid vaporization of the propellant over the range of conditions tested. Low vaporization rates led to the accumulation of liquid propellant which film boiled in the thruster. Modifications would be needed to the matrix to increase the heat transfer rates to the liquid and prevent the accumulation of propellant.

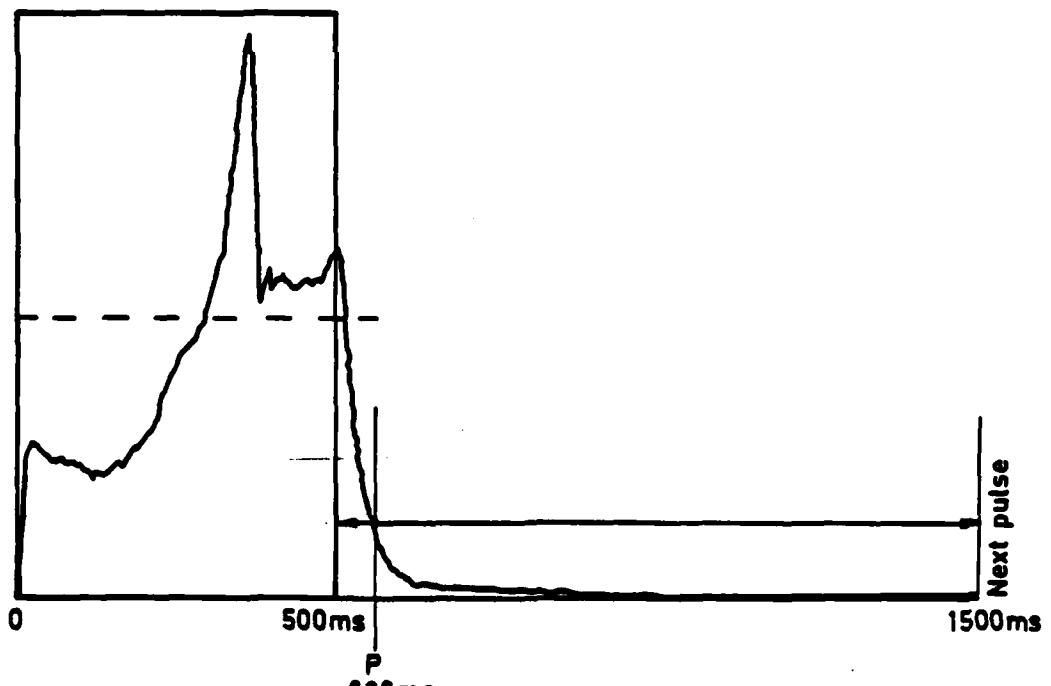
Fig 22a shows a large propellant droplet in the head space of the thruster. The droplet was formed at the end of the pulse when the accumulated liquid was prevented from contact with the gauze by film boiling. Under these conditions the droplet had a very low vaporization rate. Although the initial pressure decay was rapid, the very low vaporization rate resulted in an extremely prolonged low plenum pressure which was sometimes close to the limit of resolution of measurement. For the particular pulse shown in Fig 22b the droplet was observed for the entire pulse interval of 1 s with little reduction in size.

Fig 22a&b Single film boiling droplet of propellant in thruster after the end of a thrust pulse
(photographed at point 'P')
